INVESTIGATION OF A HIGH SPEED
DIRECTLY DRIVEN ENGINE
HYDRAULIC PUMP

F. W. Perian
Aerospace Division
Vickers Incorporated
Division of Sperry Rand Corporation

October 1966

Technical Report AFAPL-TR-66-103

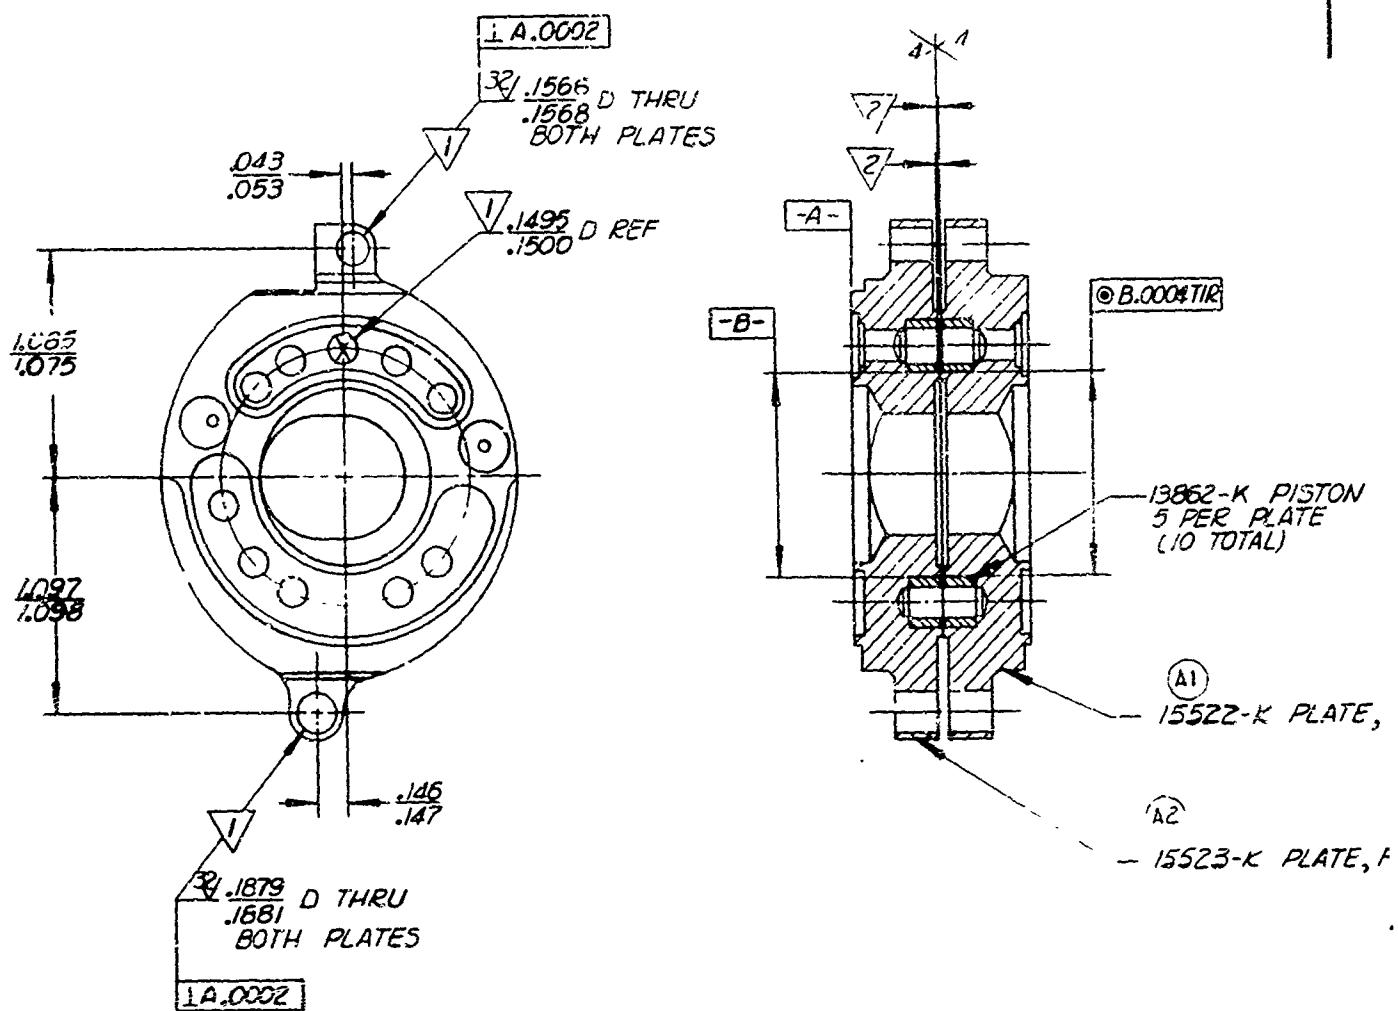
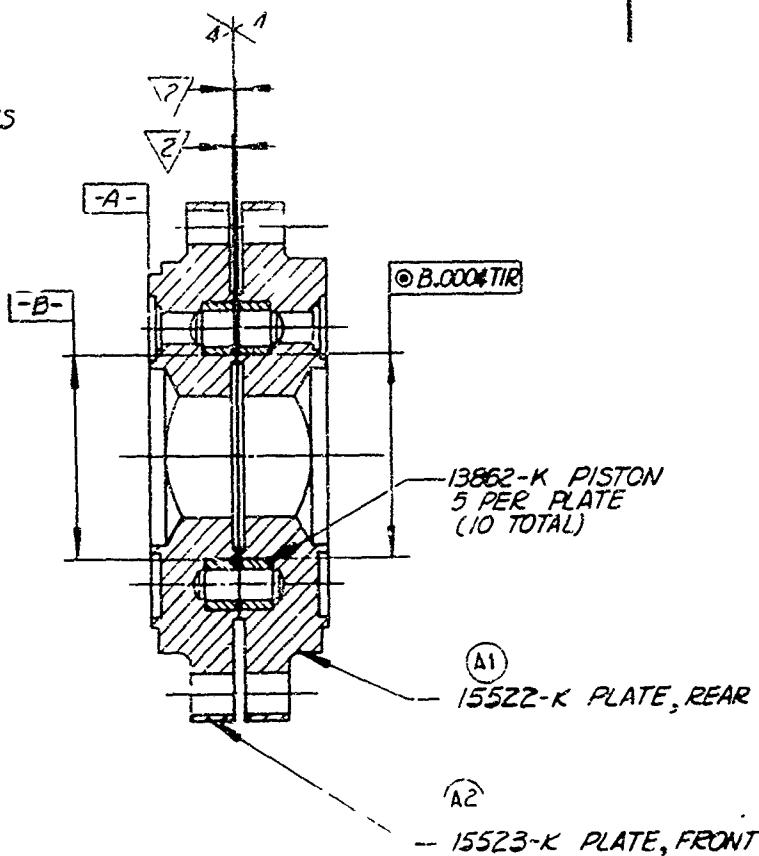
Drawing 13861-K shows the piston and annulus plate sub-assembly. Note #2 on this drawing specifies the piston fit in the annulus plate. The initial fit of the pistons is line to line to .00015" clearance. The individual pistons and annulus plate are a matched set and not interchangeable.

3. NOTE: PISTONS TO REMAIN WITH INDIVIDUAL PLATE AND MATCHED PLATES AND PISTONS NOT INTERCHANGEABLE.

**2) PISTONS TO FIT LINE TC LINE
TC .00015 CLEARANCE WITH MATING PART**

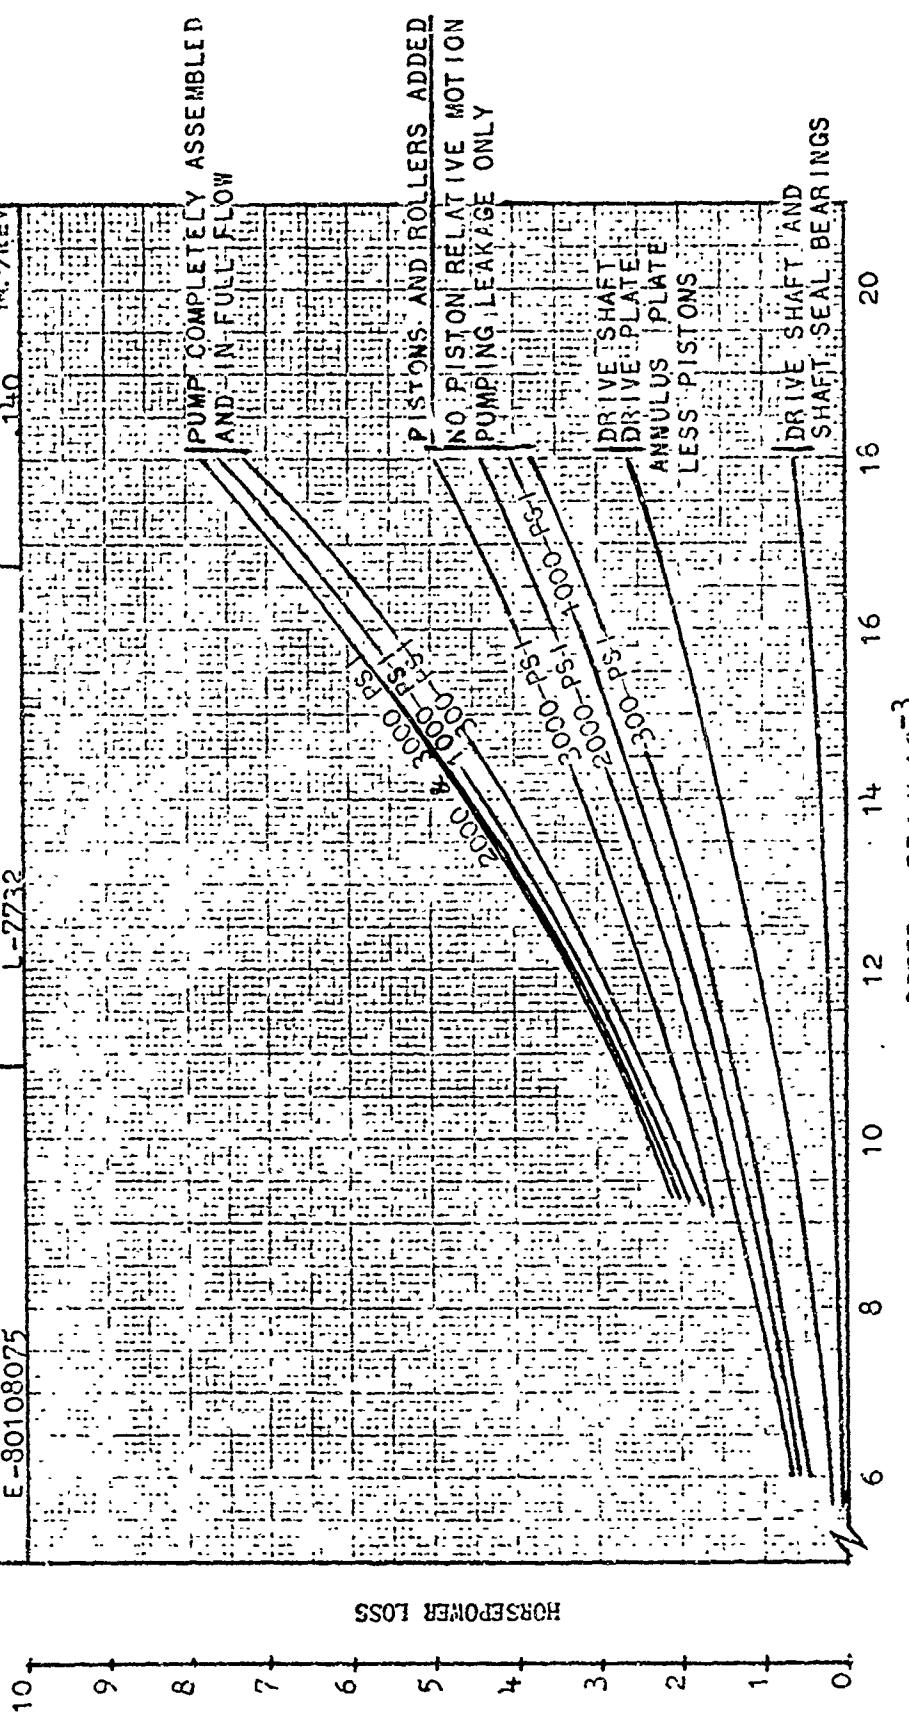
FIGURE 18 - HORSEPOWER LOSS CURVE

In an effort to determine the cause for the low overall efficiency, a series of power loss tests was conducted. The power loss tests included both mechanical and hydraulic power losses. See Figure 18. The first test consisted of running a pump with only the drive shaft bearings and shaft seal assembled. For the second test, the drive plate and annulus plates were added. The pistons and piston rollers were added for the third test. The final test was run as a completely assembled unit at both minimum flow and full flow at minimum pressure and maximum pressure.

The results of these tests showed that 45% of the power loss was caused by the rollers moving in the drive plate. 25.6% of the power loss was caused by friction between the drive plate and annulus plates. These two areas accounted for the majority of the power loss.

The highest percentage of horsepower loss (45%) was caused by the relative motion between the piston rollers and the drive plate. This motion is inherent in the design and is proportional to the pump stroke. At minimum flow, the movement between the rollers and drive plate is small and the horsepower losses are low. As the displacement is increased at a constant pressure, the losses increase proportionally to pump stroke.

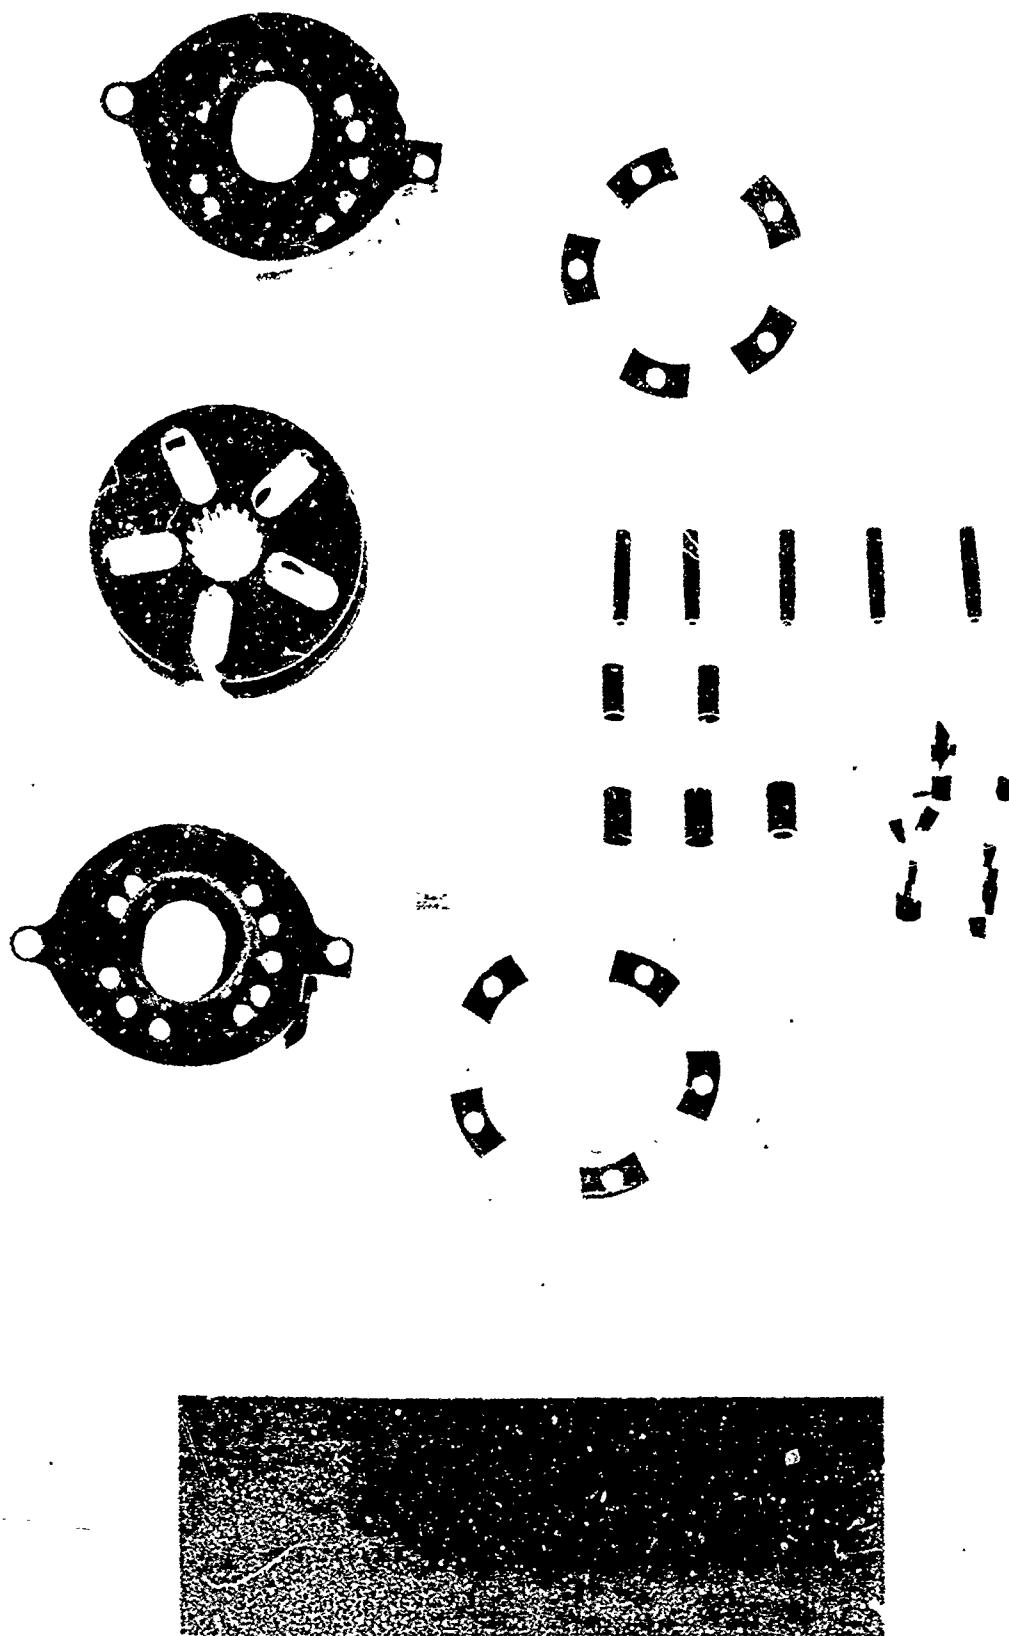
Figure 19 - Failed Rotating Group

The calibration of the unit was completed for 25, 50, 75, and 100% of rated speed. Readings were taken at 100, 75, 50, 25 and 0% of full flow. On the last reading of the calibration test, at 110% of rated speed (19,800 RPM), the unit failed.

The cause of the failure was piston binding in the annulus groove. During operation at high speed, small particles of silver were removed from the annulus grooves.

The impact load at this point on the piston rollers caused the rollers to crack. Part of the broken roller in one slot wedged between the pin and the drive plate slot end breaking the drive plate. See Figure 19.

- (1) The silver plating of the annulus groove was reduced to .0002"/.0004" thickness.
- (2) The timing and metering of the ports was changed.
- (3) The hydraulic balance of the annulus plates was changed to reduce wear and friction.

The unit was then rebuilt with the changes as recommended.
